**DEPARTMENT OF TRANSPORTATION**

Contract #: 04-0120F4Cty: SF/ALA Rte: 80 PM: 13.2/13.9File #: 99.28**WELDING INSPECTION REPORT****Resident Engineer:**Siegenthaler, Peter**Address:** 333 Burma Road**City:** Oakland, CA 94607**Report No:** WIR-019088**Date Inspected:** 11-Dec-2010**Project Name:** SAS Superstructure**OSM Arrival Time:** 700**Prime Contractor:** American Bridge/Fluor Enterprises, a JV**OSM Departure Time:** 1900**Contractor:** Zhenhua Port Machinery Company, Ltd (ZPMC) Chanxing Island**Location:** Shanghai, China**CWI Name:** Mr. Xu Tao**CWI Present:** Yes No**Inspected CWI report:** Yes No N/A**Rod Oven in Use:** Yes No N/A**Electrode to specification:** Yes No N/A**Weld Procedures Followed:** Yes No N/A**Qualified Welders:** Yes No N/A**Verified Joint Fit-up:** Yes No N/A**Approved Drawings:** Yes No N/A**Approved WPS:** Yes No N/A**Delayed / Cancelled:** Yes No N/A**Bridge No:** 34-0006**Component:** OBG Bike Path**Summary of Items Observed:**

## WELDING INSPECTION REPORT

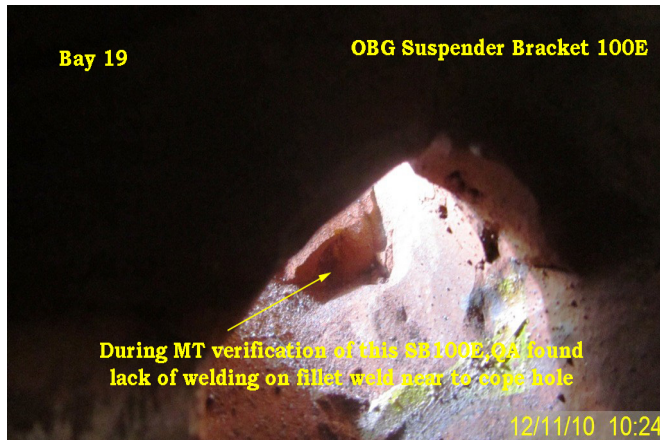
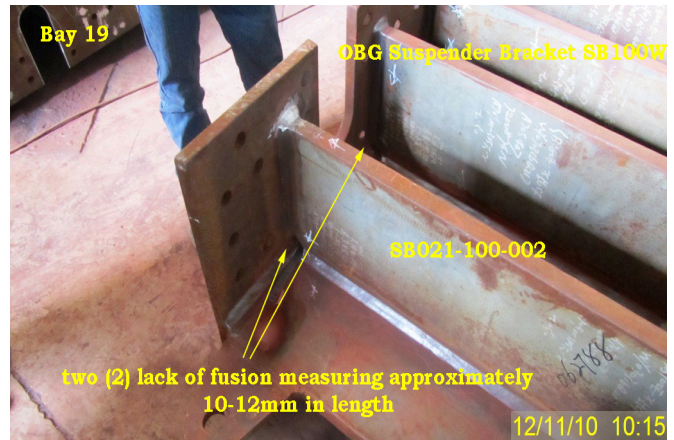
Description of Incident: During the Quality Assurance Magnetic Particle Testing (MT) review of welds located on OBG Suspender Bracket SB100W and 100E, this Quality Assurance Inspector (QA) discovered that two (2) lack of fusion measuring approximately 10-12mm in length. The weld is identified as: SB021-100-002. This weld is a fillet weld joining the side plate to web stiffener. This weld is designated as non Seismic Performance Critical Member (non SPCM). The indication is clearly marked on the material near the weld. OBG Suspender Bracket is located South Side of Bay 19 area. The Indication is located within an area that has been previously tested by ZPMC Quality Control (QC) personnel. As per contract documents ZPMC is required to perform 100% Magnetic particle Testing (MT) of this weld. The ZPMC QC is identified as Mr. Xu Tao. See the attaché picture.
